A REPORT BY WILD VIRGINIA

FEBRUARY 2023

MOUNTAIN VALLEY PIPELINE POLLUTION IN VIRGINIA WATERSHEDS

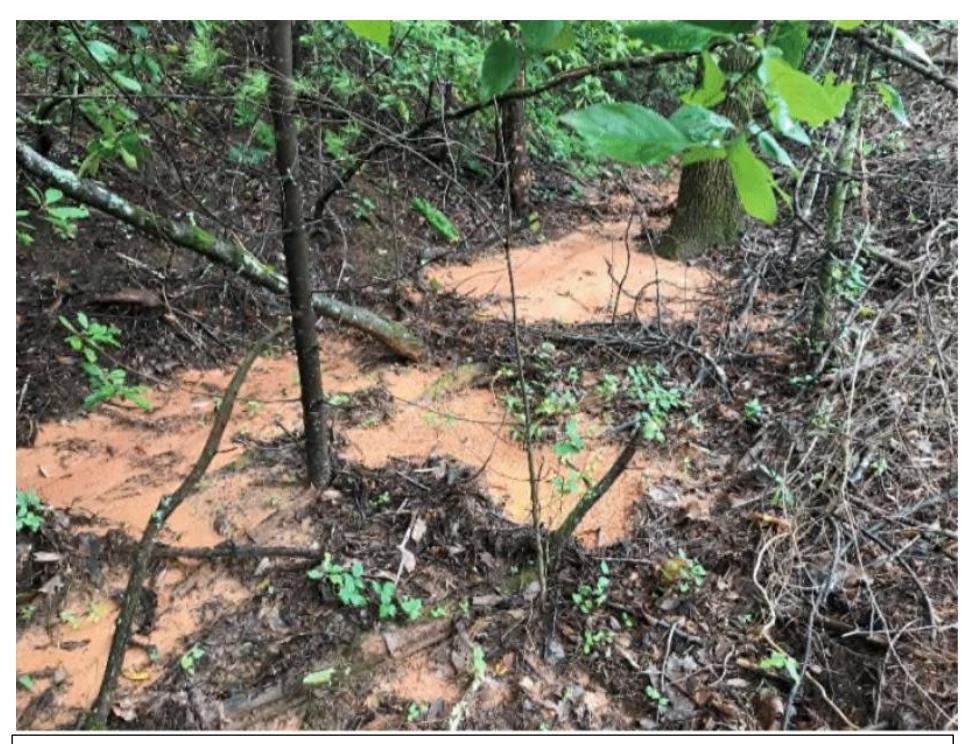
Figure 1 - Sediment deposits in UT to Blackwater River, August 1, 2018, DEQ Inspection, Spread I, Source: DEQ [report says "sediment appears to have been removed from stream" on Aug. 15, 2018]

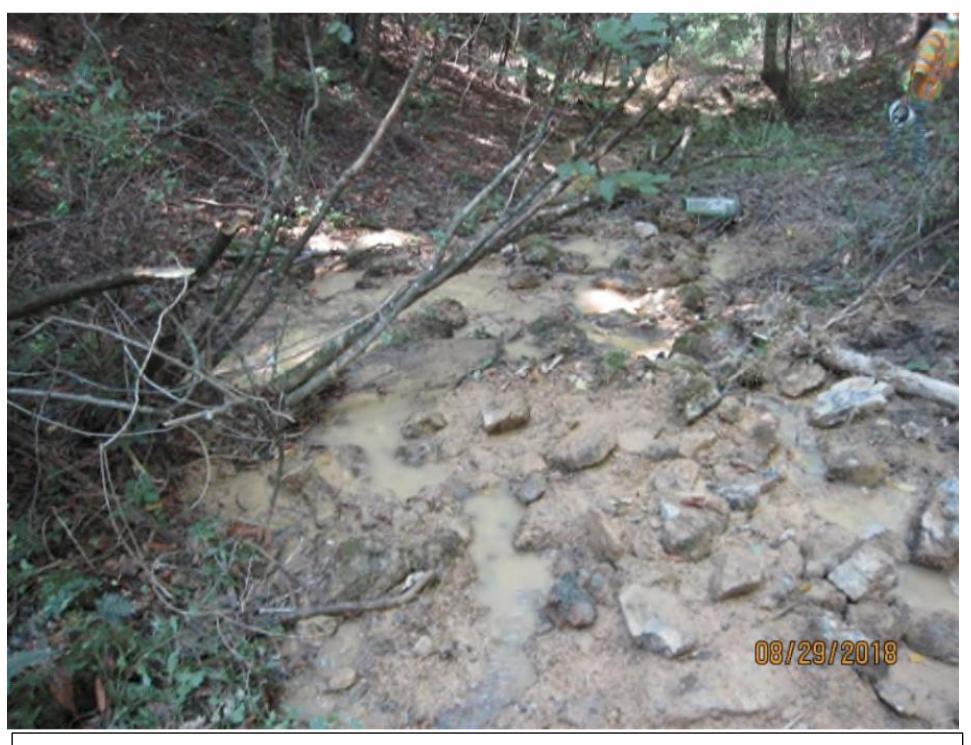
Figure 2 - Sediment deposited in UT to Sinking Creek, August 29, 2018, DEQ VWP inspection, Source: DEQ [notes that sediment shown approx., 300 ft. downstream from ROW]

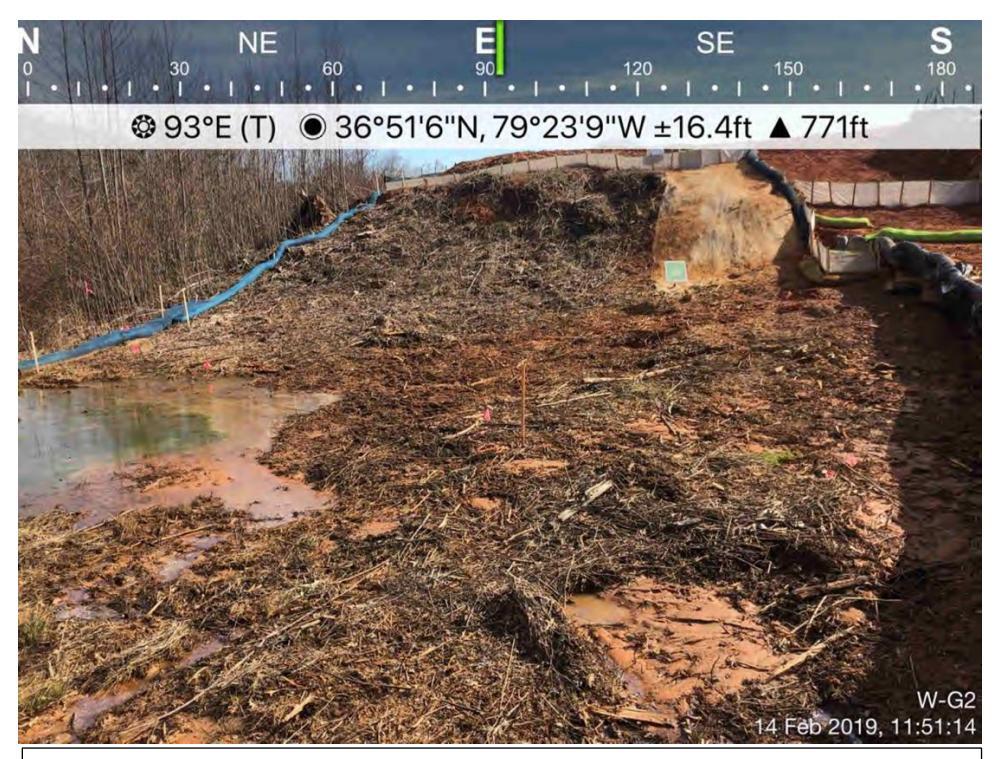
Figure 3 - Sediment deposited in wetland W-G2, adjacent to Little Cherrystone Cr., February 12, 2019, Action Log ID 1888, Source: MBP [deadline for removal of sediment extended "due to wet ROW conditions," removed after 10 days]

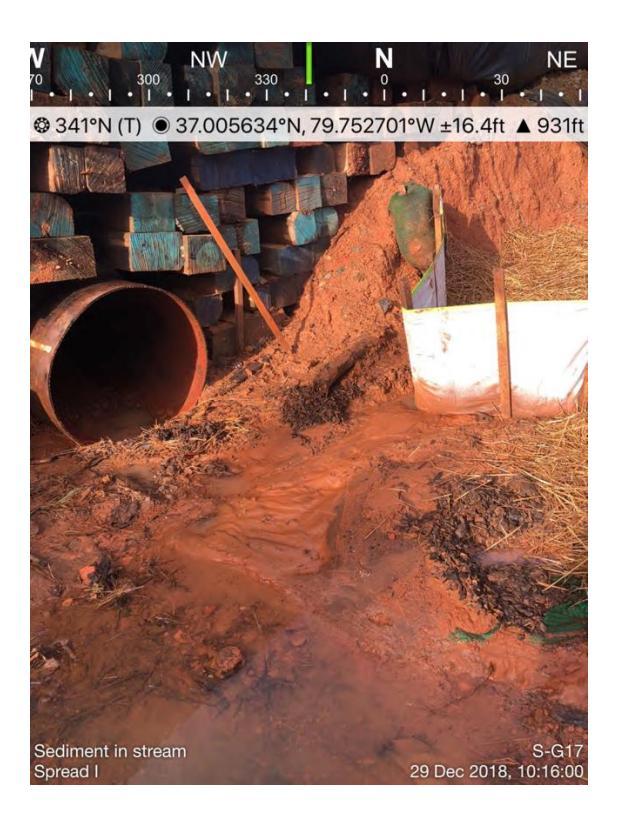
Figure 4 - Sediment deposited in UT Blackwater River, December 29, 2018, Action Log ID 1562, Source: MBP

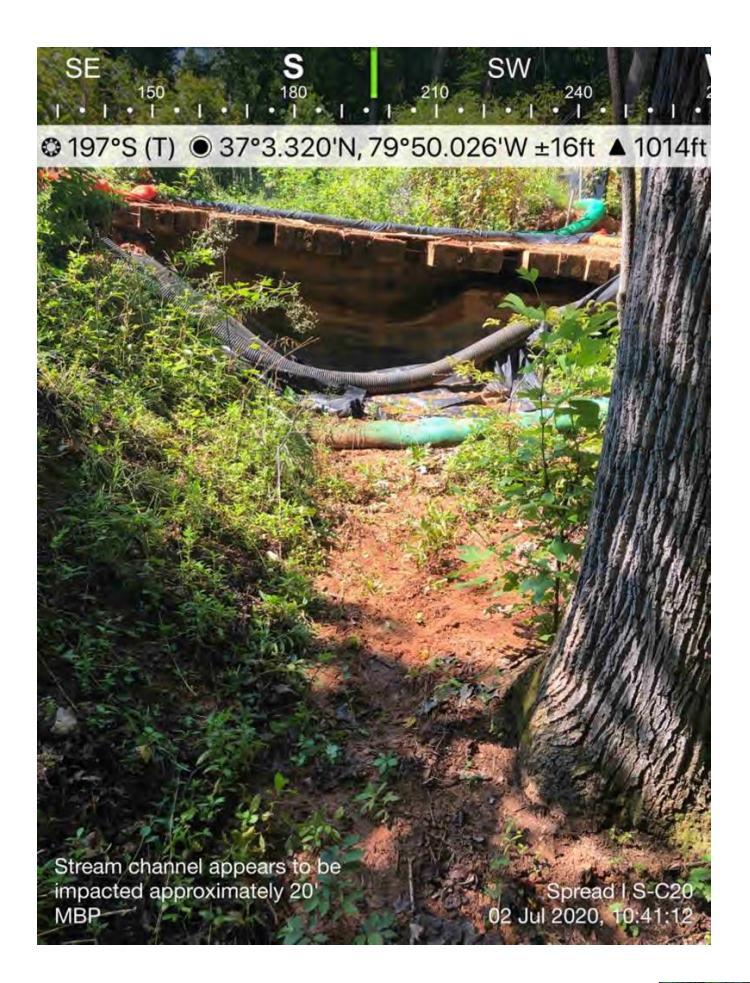
Figure 5 - Sediment deposited in UT to Maggodee Creek, July 2, 2020, Action Log ID 4313, Source: MBP. [report states deposits 2.5 inches deep, 3 ft. wide, covering approx. 20 linear feet of bed; deposits in place five days before removal.

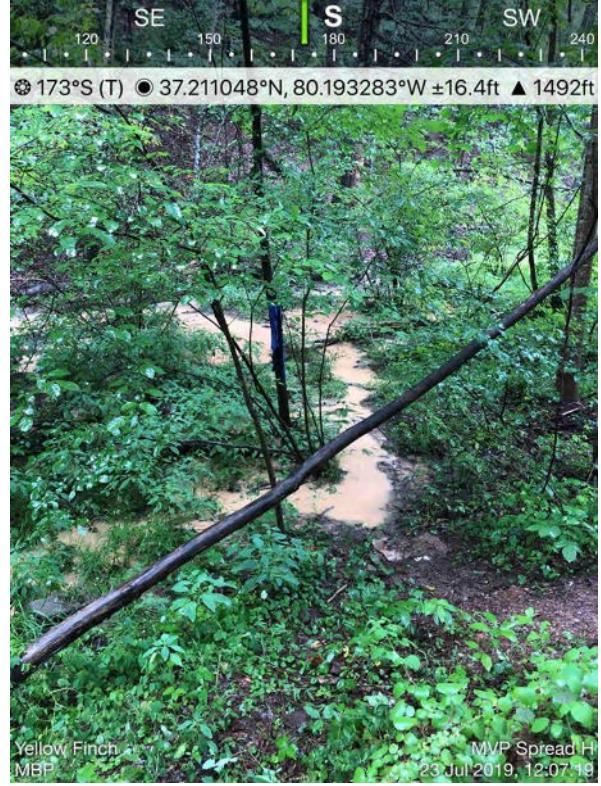
Figure 6 - Sediment deposited in UT to Roanoke River, July 23, 2019, Action Log ID 3301, Source: MBP [failure to recover sediment without landowner agreement, after 72 days sediment had washed away]

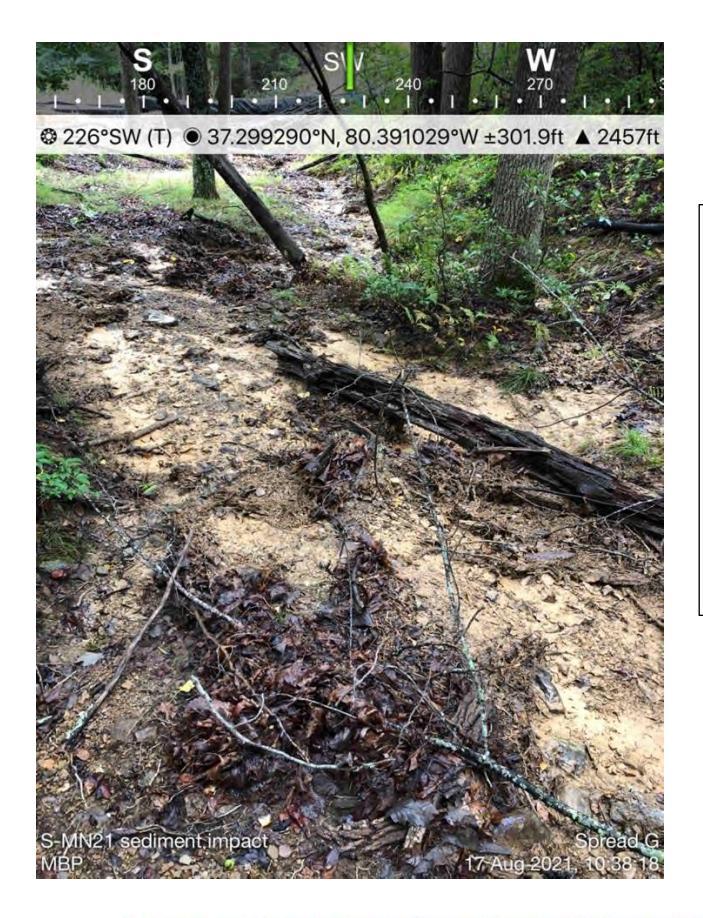
Figure 7 - Sediment deposited in UT to Mill Creek and on adjacent property, August 16, 2021, Action Log ID 5035, deadline to clean up extended while seeking landowner permission [report states impacts extend approx. 75 linear feet upstream and 100 linear feet downstream; landowner denied permission to access impacted areas; approx. 3 months later, inspector reported sediment deposits no longer visible.

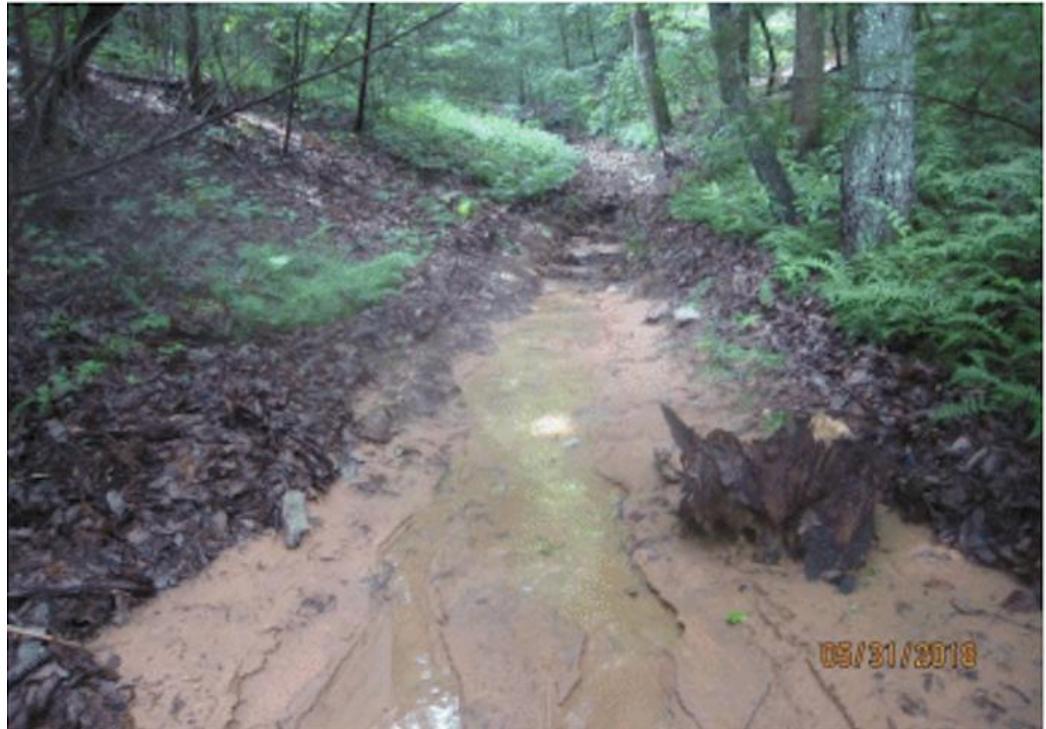
Figure 8 - Sediment deposited in UT to Blackwater River, May 31, 2018, DEQ VWP inspection rpt. [sediment in streambed approx. 1,690 linear feet of stream impacted with deposits up to 5 inches deep; impacted area approx. 685 feet from ROW]

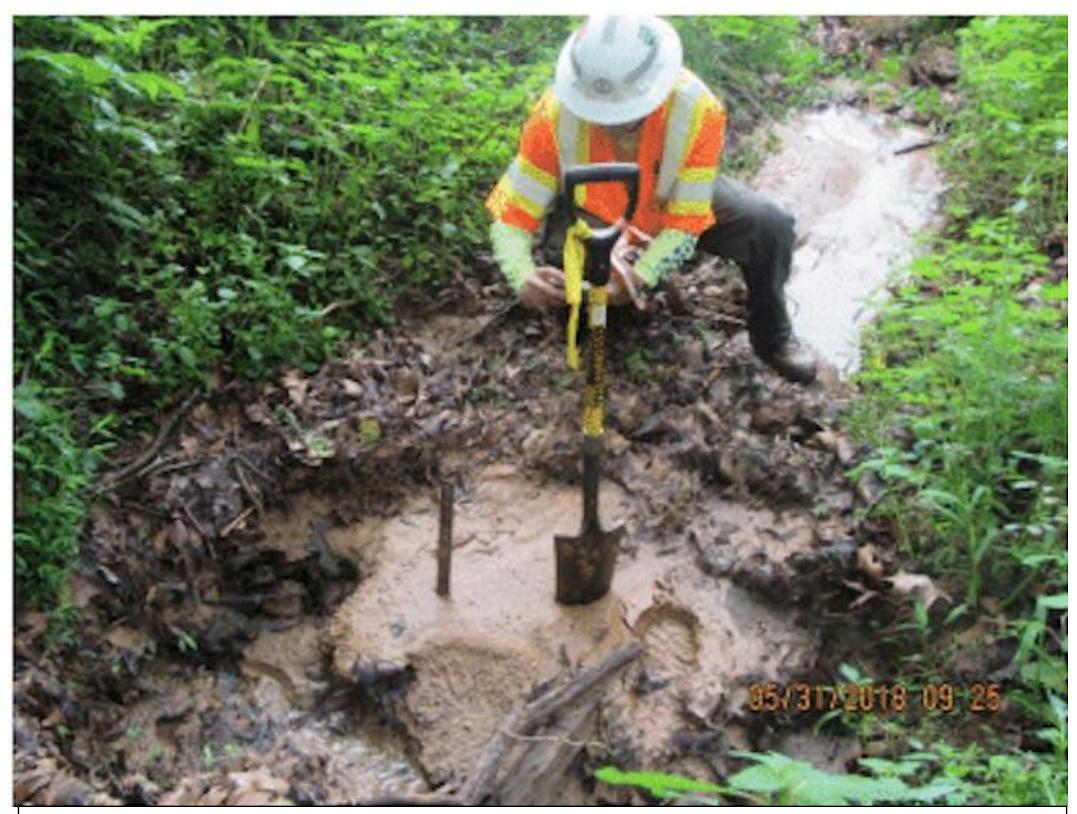
Figure 9 - Sediment deposited in UT to Blackwater River, May 31, 2018, DEQ VWP inspection report, Source: DEQ [sediment covered approx. 1,110 linear feet of streambed, up to 7 inches deep]

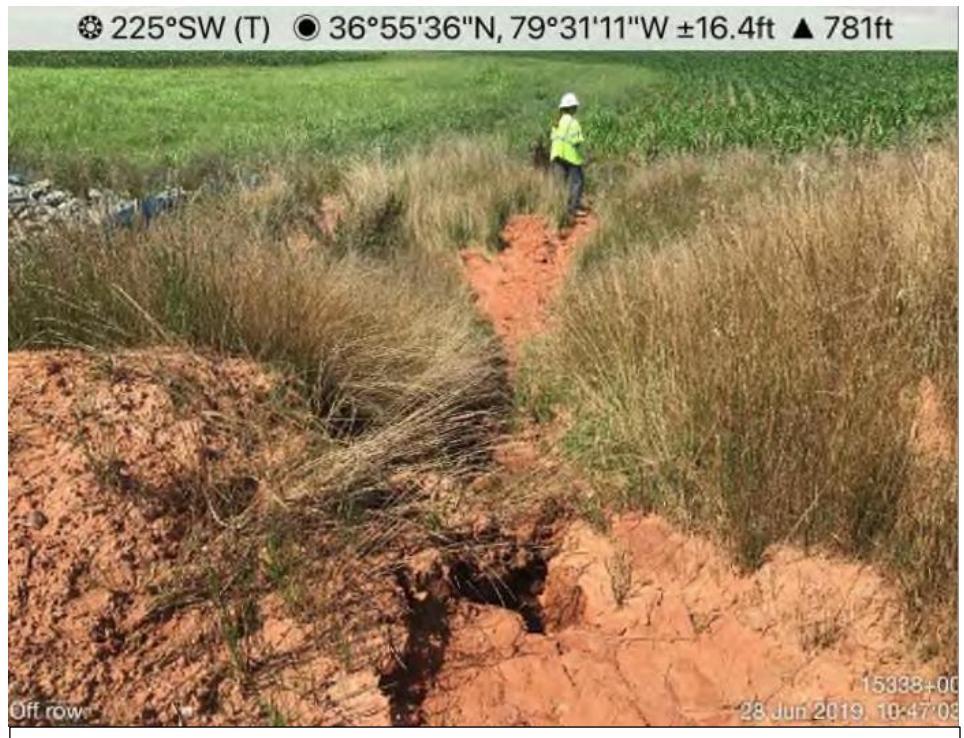
Figure 10 - Sediment deposits off ROW onto a farm field, near UT to Harpen Creek, June 28, 2019, DEQ Inspec. Rpt. Spread I, Source: DEQ

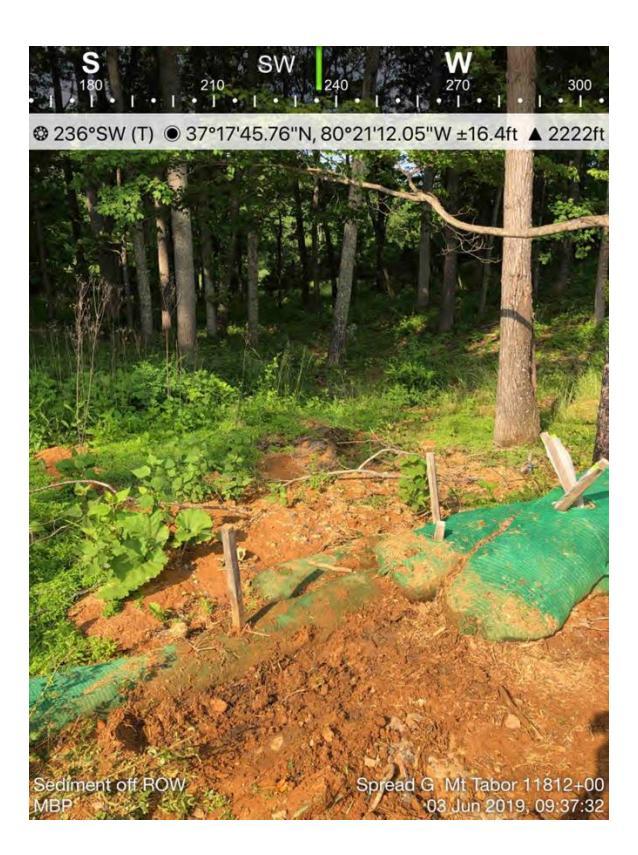
Figure 11 - Sediment deposited off ROW, June 3, 2019, Action Item ID 2844, near Dry Run, Source: MBP

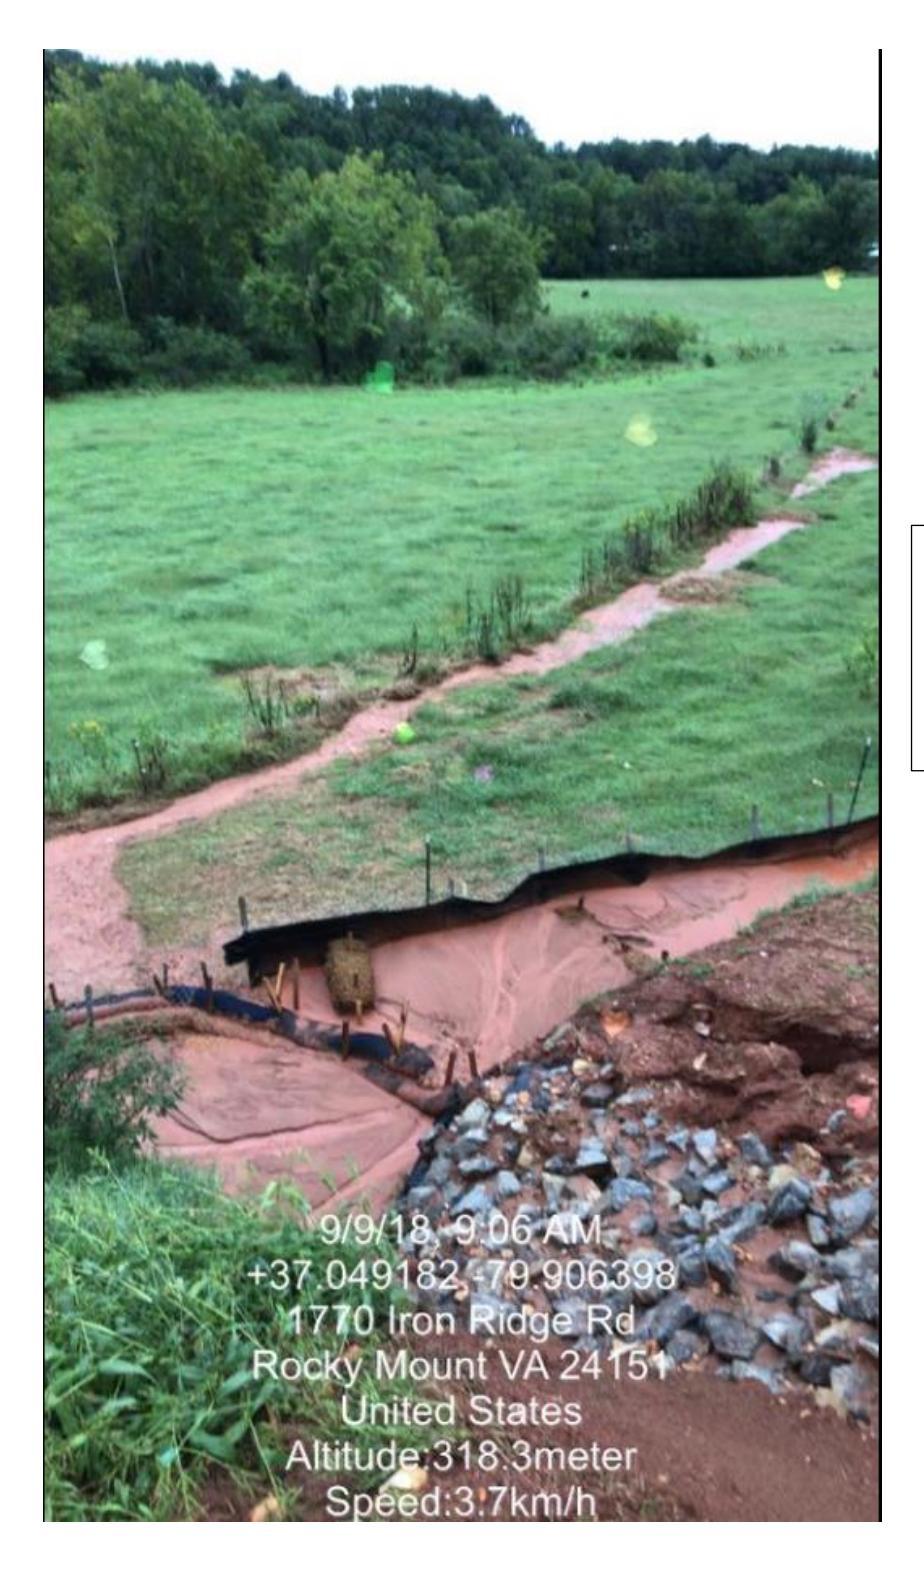
Figure 12 - Sediment off ROW near UT to Little Creek, September 9, 2018, Source: citizen observer, accessible at <u>Virginia</u> <u>Pipeline Violations</u> <u>Facebook page</u> Untreated or Poorly Treated Discharges from MVP Sites

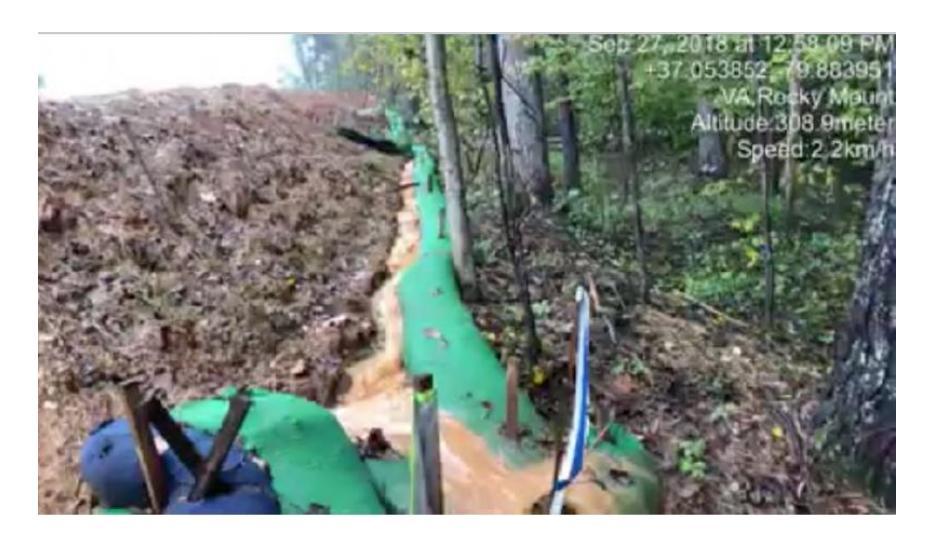
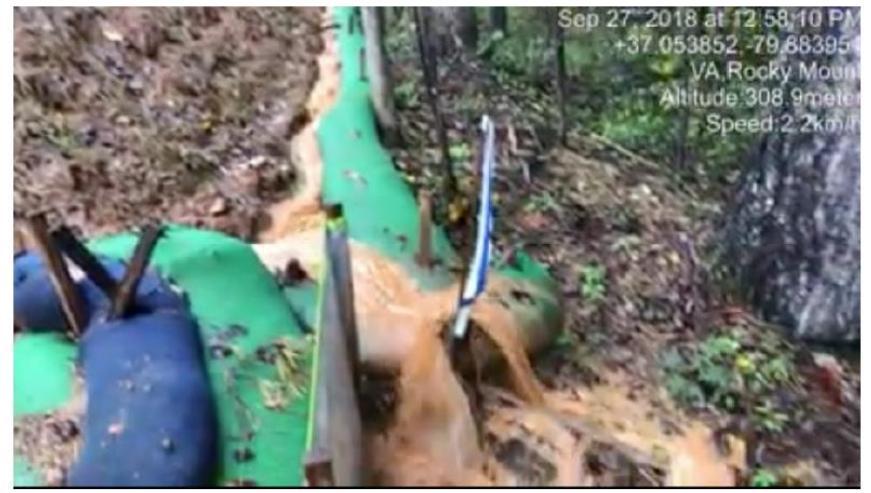
Figures 13 - 15 -

September 27, 2018

Taken from a <u>video</u> <u>accessible at</u> <u>Virginia Pipeline</u> <u>Violations</u> Facebook page

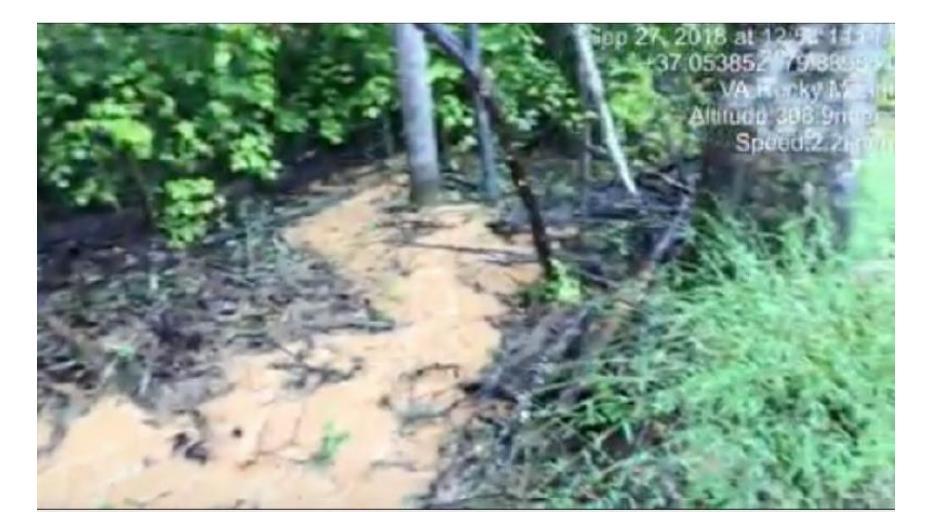
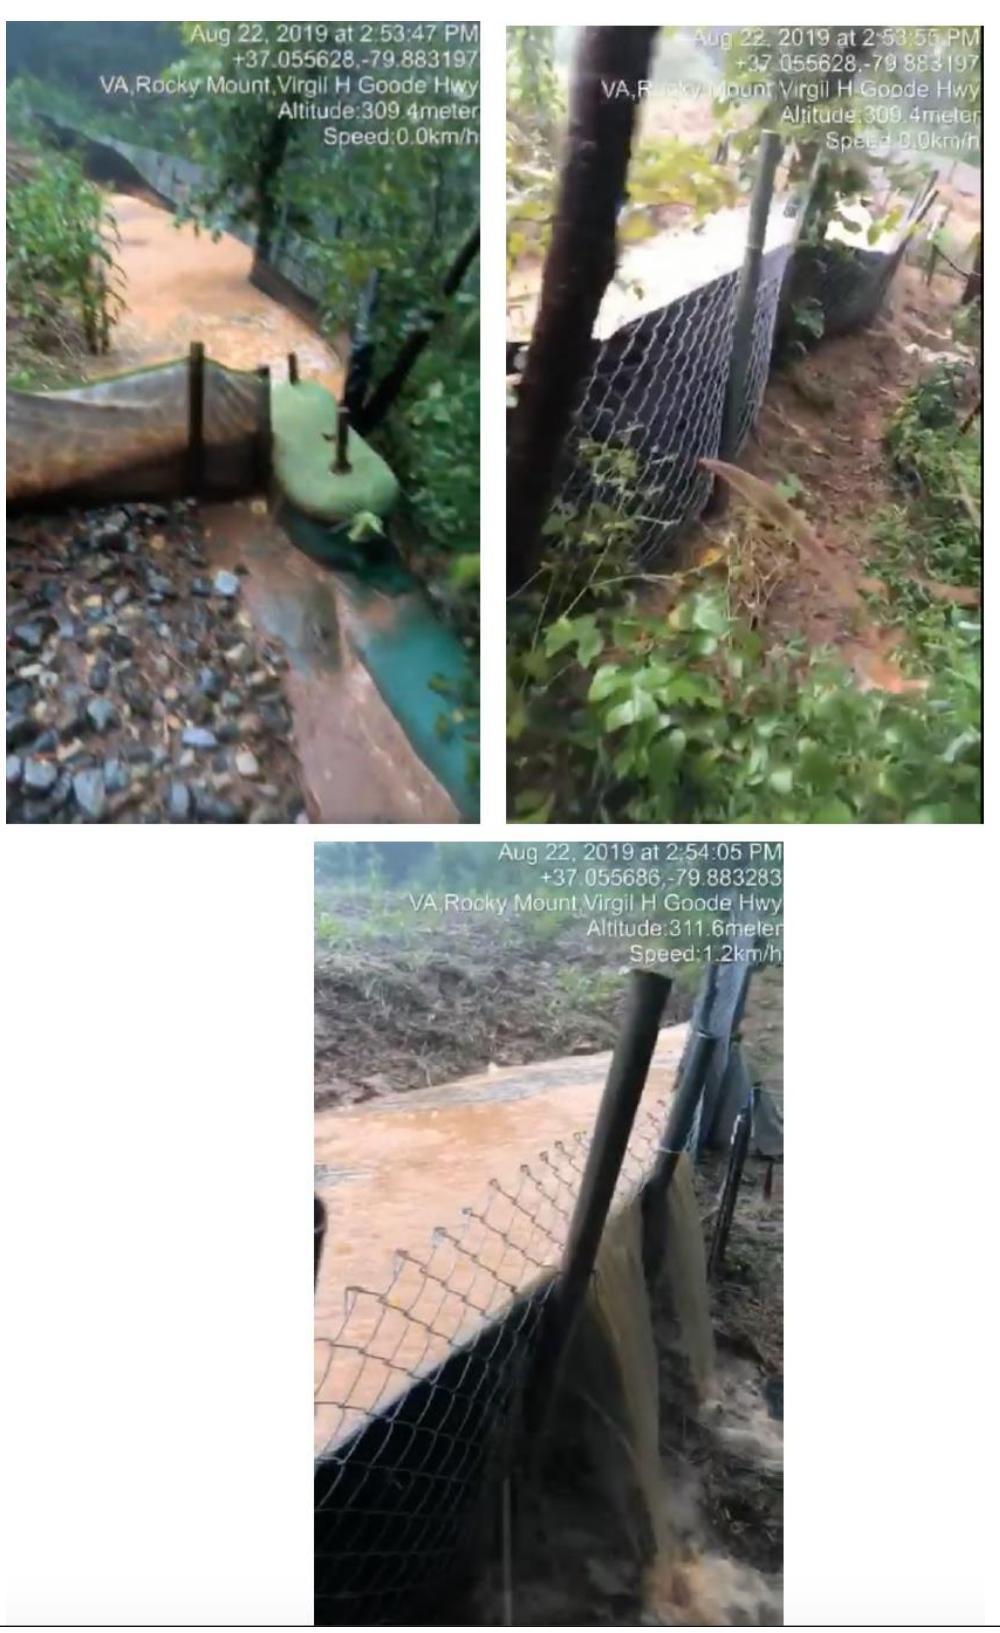
Figures 16 - 18 - August 22, 2019 Sediment-laden water flowing over, around, and through super silt fence and leaving the MVP ROW, several hundred feet upslope of the Blackwater River. Taken from a <u>video accessible at Virginia Pipeline Violations Facebook page</u>

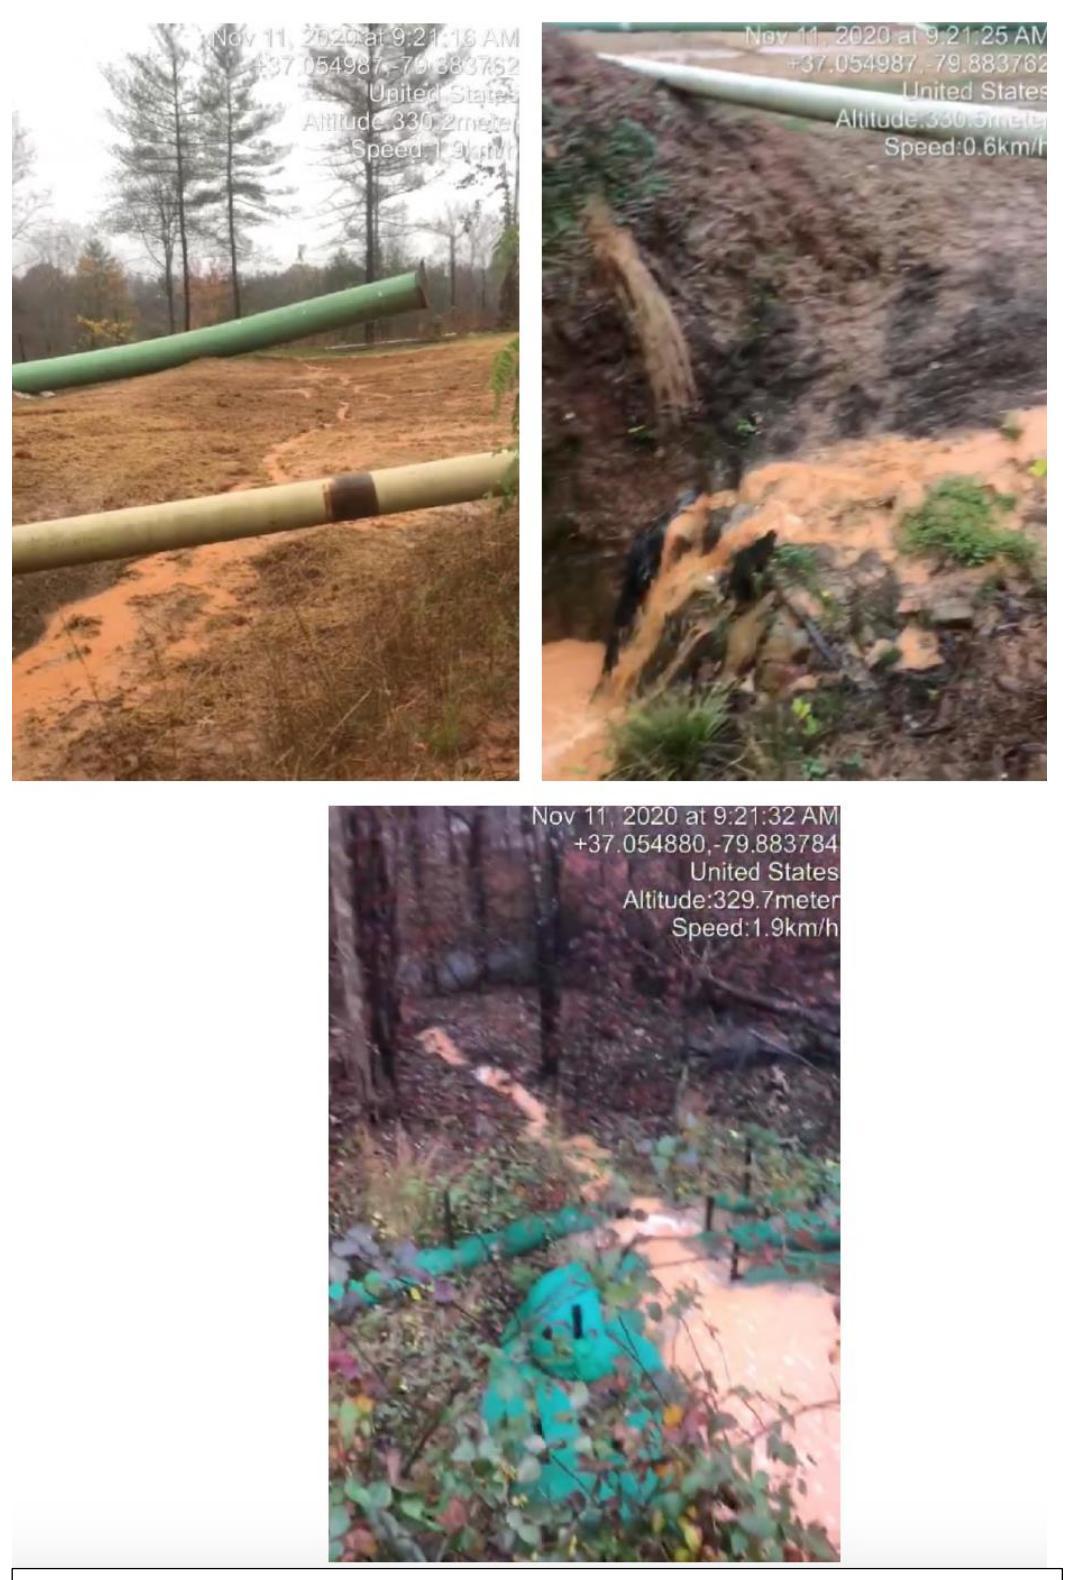
Figures 19 - 21 - November 11, 2020, Sediment-laden water overwhelming an end treatment and leaving the MVP ROW, several hundred feet upslope of the Blackwater River. Taken from a <u>video accessible at Virginia Pipeline Violations Facebook page</u>

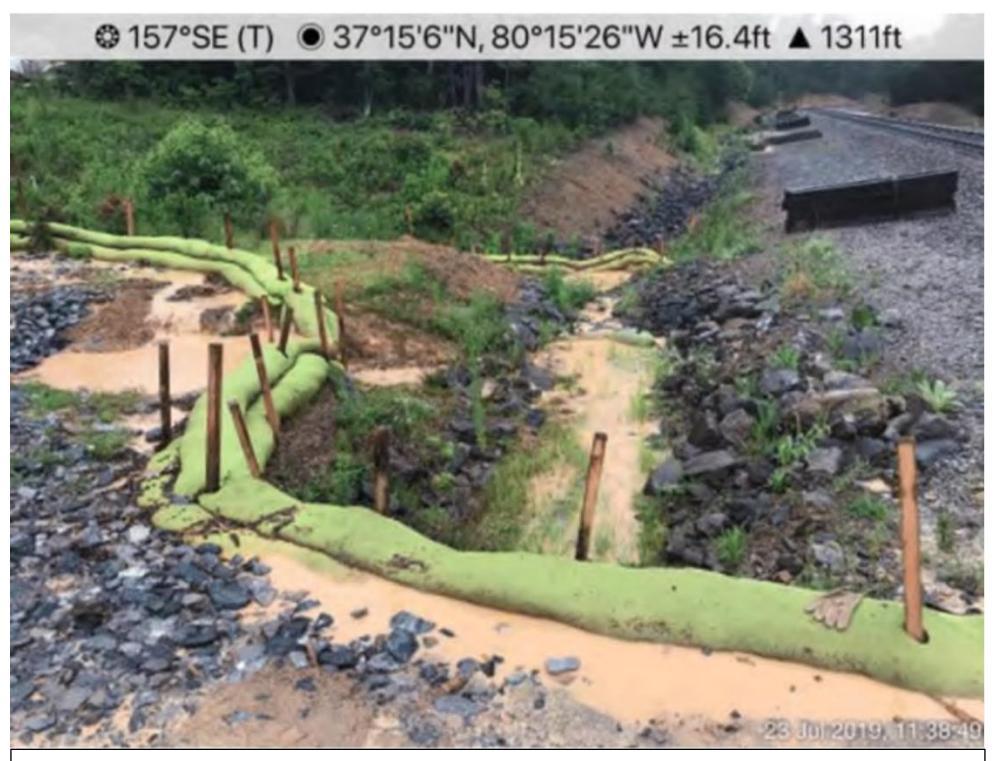
Figure 23 - Sediment-laden water undermining compost filters socks and discharging to a UT of Bradshaw Creek, July 23, 2019, DEQ Complaint inspection report, Source: DEQ [Bradshaw Creek is within the range of the Endangered Roanoke Logperch]

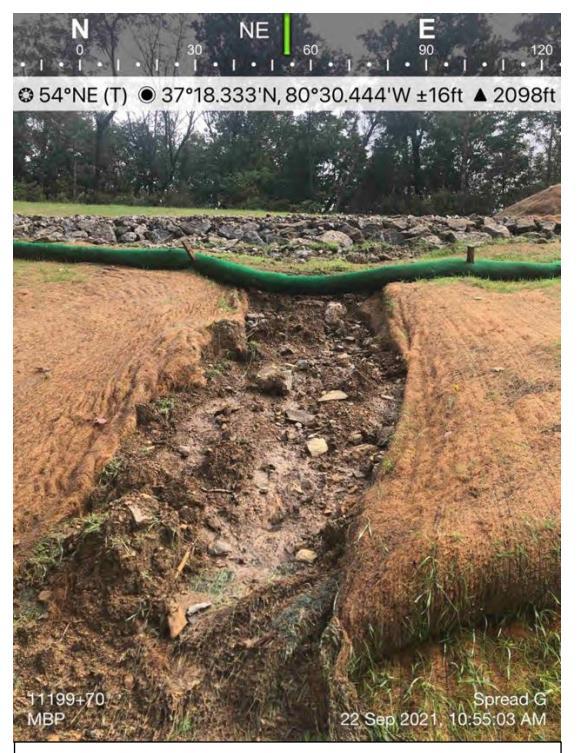
Figure 24 - Compost filter sock undermined near Sinking Creek, September 22, 2021, Action Log ID 5196, Source: MBP

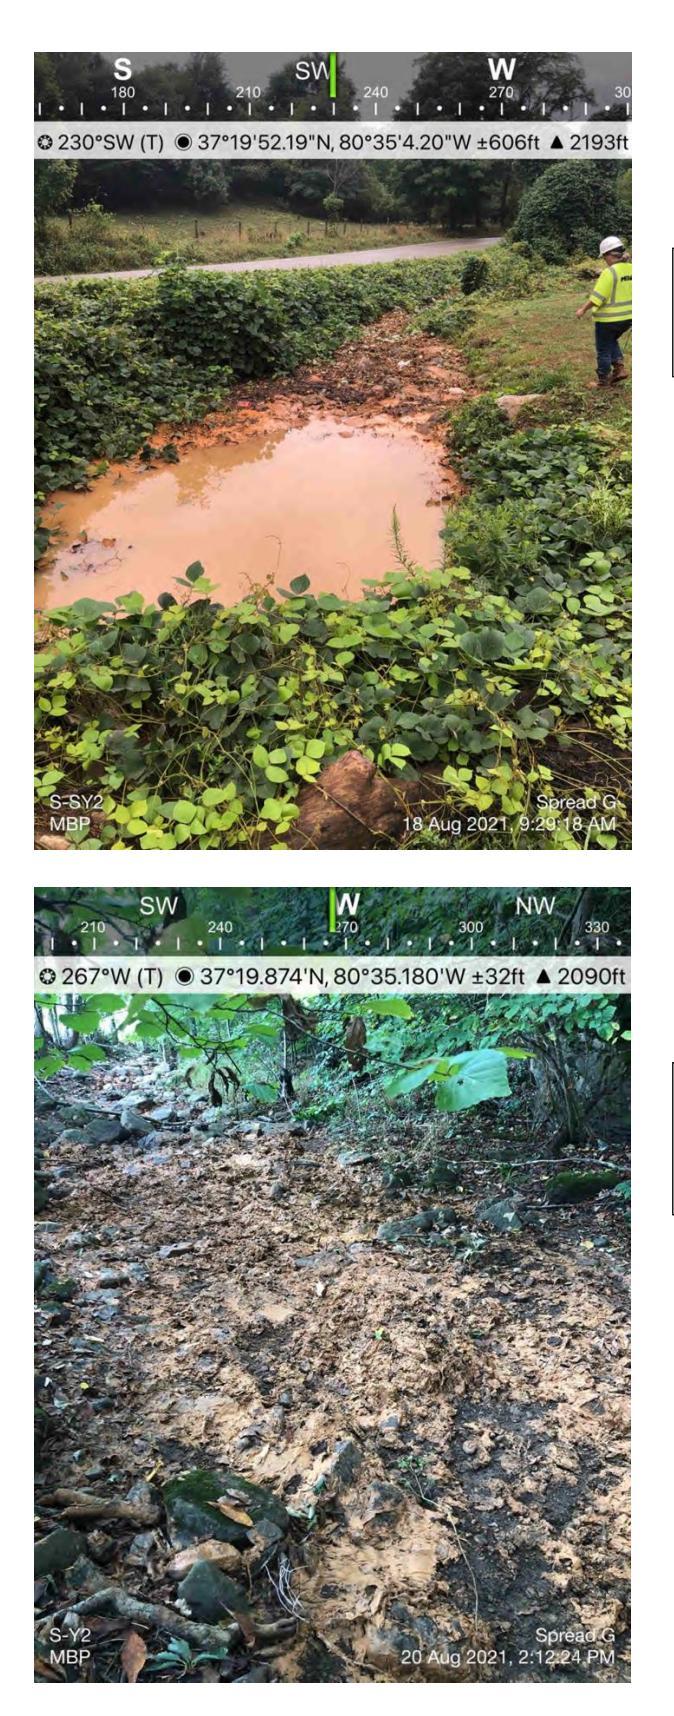
Figure 26 - Sediment deposited in Doe Creek, August 18, 2021, Action Log ID 5068, Source: MBP

Figure 27 - Sediment deposited off MVP ROW near Doe Creek, August 18, 2021, Action Log ID 5068, Source: MBP **Figure 28** - Workers using a pressure washer and pump truck in an attempt to remove sediment deposited in Doe Creek from MVP worksites. August 20, 2021. Action Log ID 5068. Source: MBP

[Inspectors first identified this pollution incident on August 18, 2021 and the MBP report lists the "item corrected date" as September 2, 2021, fifteen days after the stream impact occurred.]

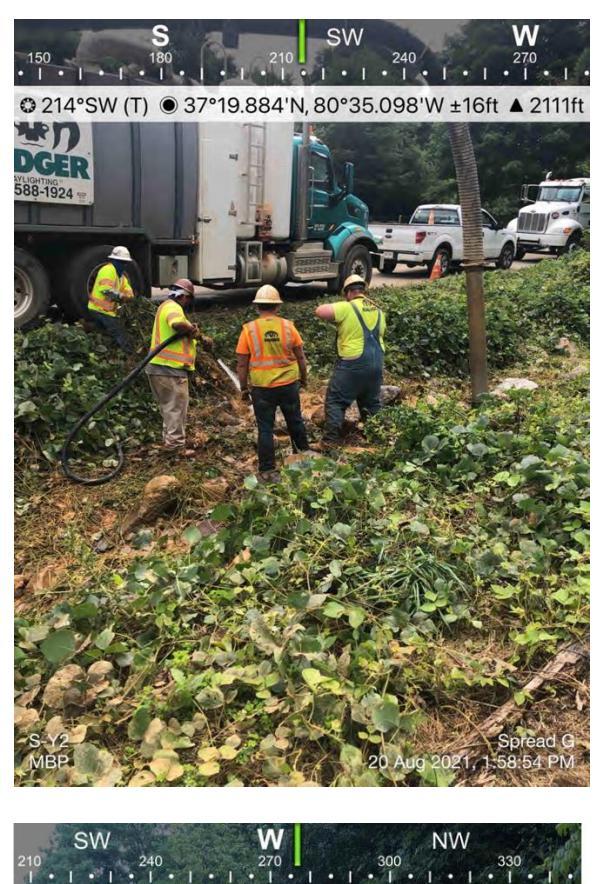
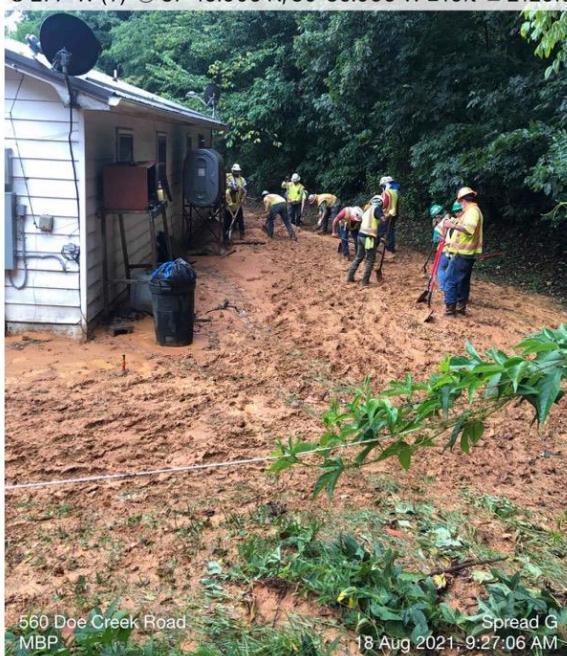
Figure 29 - Workers removing sediment from a landowner's property after the pollution "overwhelmed perimeter controls" at MVP sites. Action Log ID 5067. Source: MBP

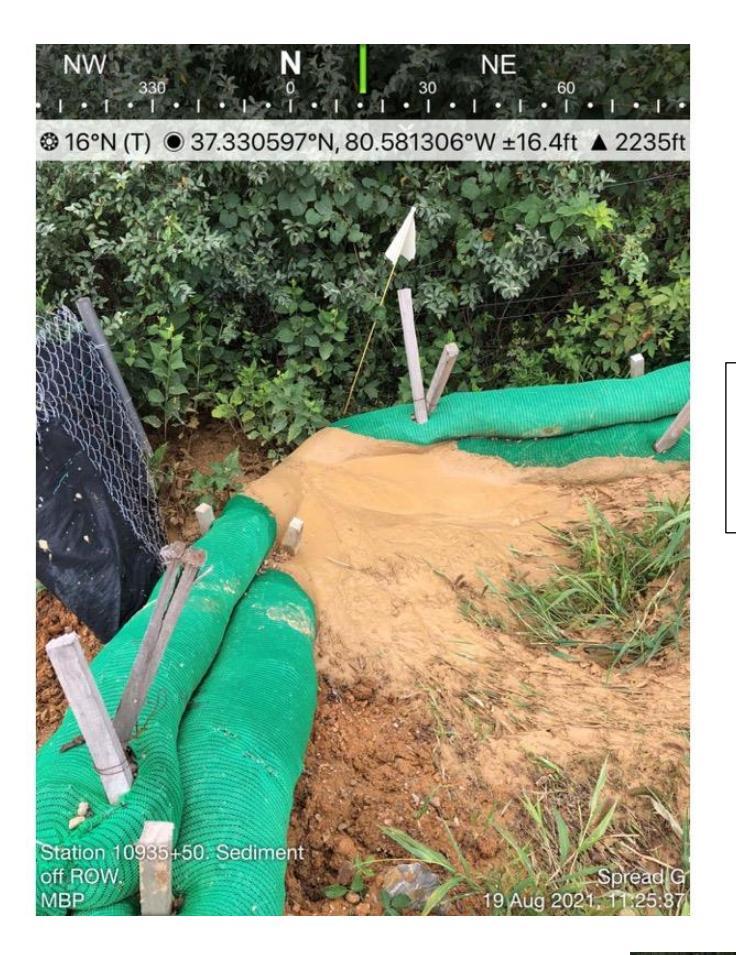
Figure 30 - Sediment overflowing compost filter socks, deposited off MVP ROW near UT to Doe Creek, August 19, 2021, Action Log ID 5081, Source: MBP

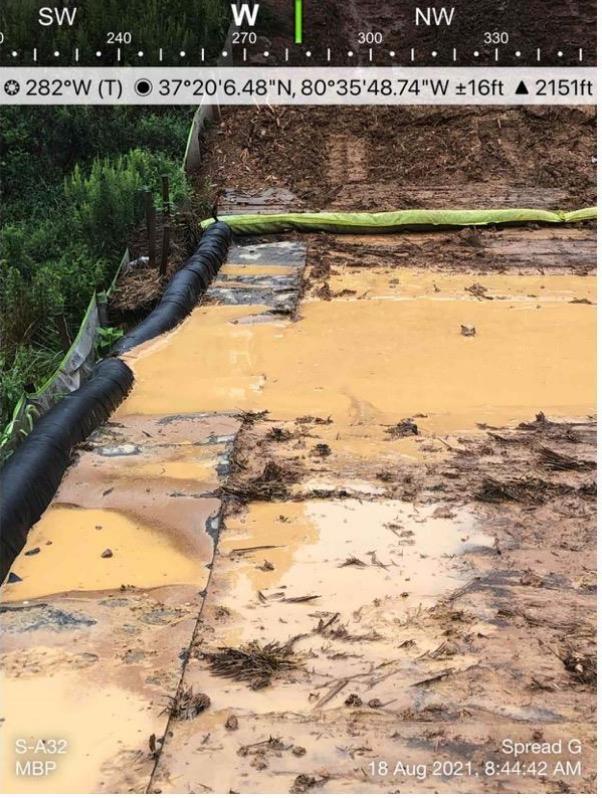
Figure 31 - Sediment deposited in UT to Doe Creek, August 18, 2021, Action Log ID 5065, Source: MBP

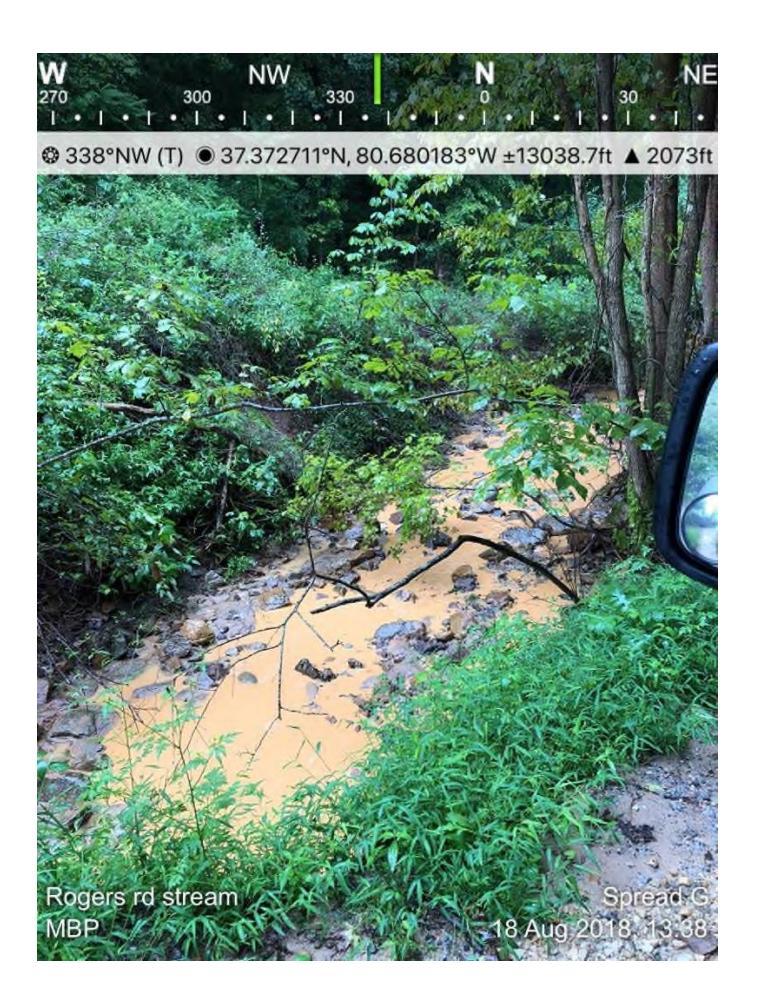
Figure 33 - Sediment deposited in Kimballton Branch, August 18, 2018, Action Log ID 604, Source: MBP

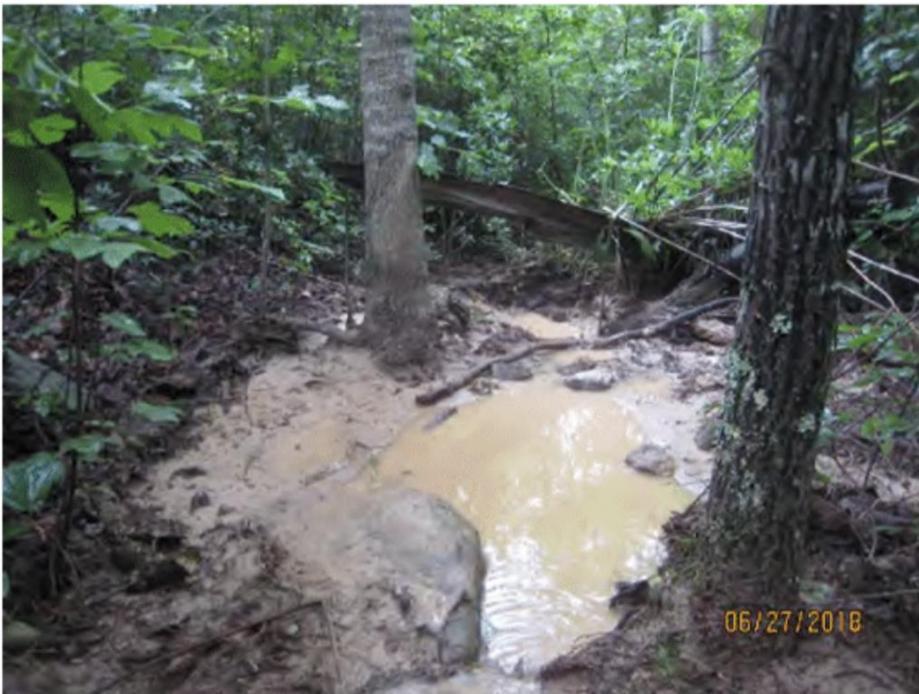
Photo 1: Sedimentation within "SMM-15" ~160' downstream of LOD; Depth = 3" **Orientation:** Downstream

Figure 36- Sediment deposits in UT Flatwoods Branch, June 27, 2018, VWP Inspection Report, Source: DEQ [original photo caption retained]

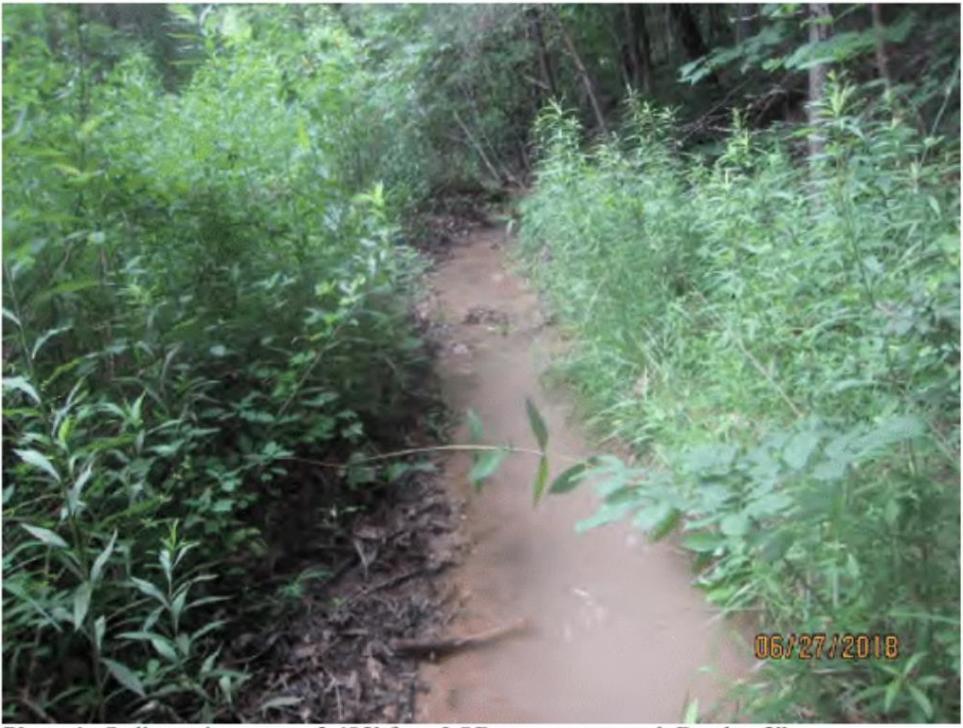
Photo 4: Sediment in stream ~3,485' from LOD near access road; Depth = 2" Orientation: Downstream

Figure 37- Sediment deposits in UT Flatwoods Branch, June 27, 2018, VWP Inspection Report, Source: DEQ [original photo caption retained]

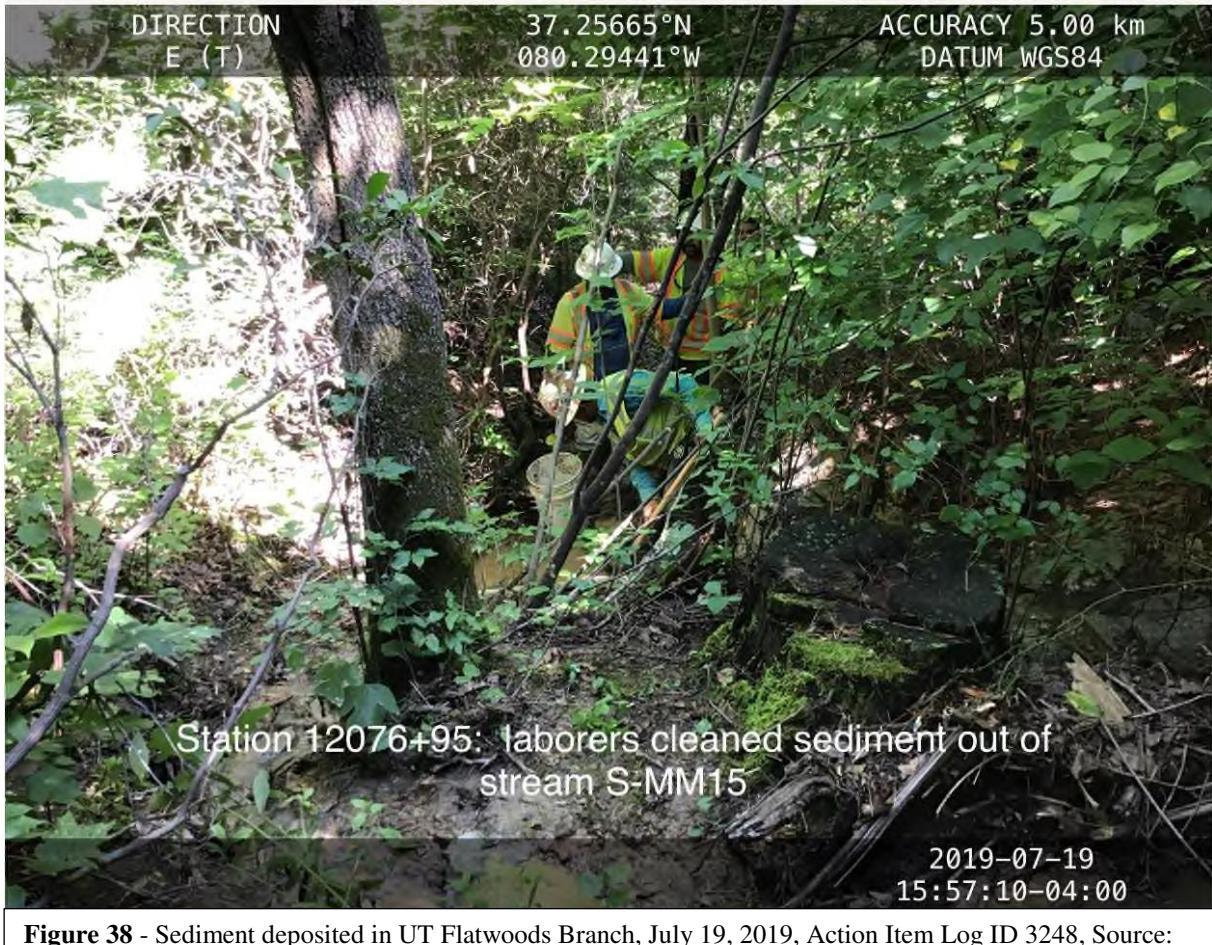
Figure 38 - Sediment deposited in UT Flatwoods Branch, July 19, 2019, Action Item Log ID 3248, Source: MBP [This is an example of what inspectors often term "remediation" through physial removal of sediments from the stream, using shovels and buckets.]
