A REPORT BY WILD VIRGINIA

FEBRUARY 2023

MOUNTAIN VALLEY PIPELINE POLLUTION IN VIRGINIA WATERSHEDS

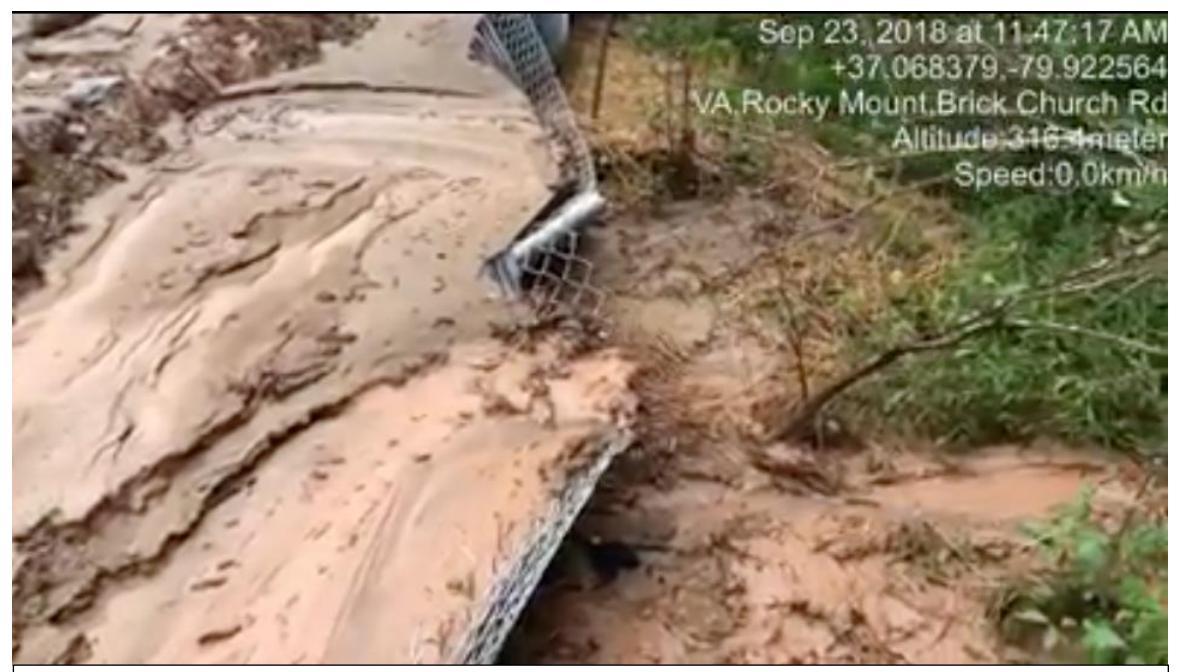
Figure 39 - Sediment deposits off ROW, at UT to Teels Creek, September 23, 2018, Source: citizen monitor

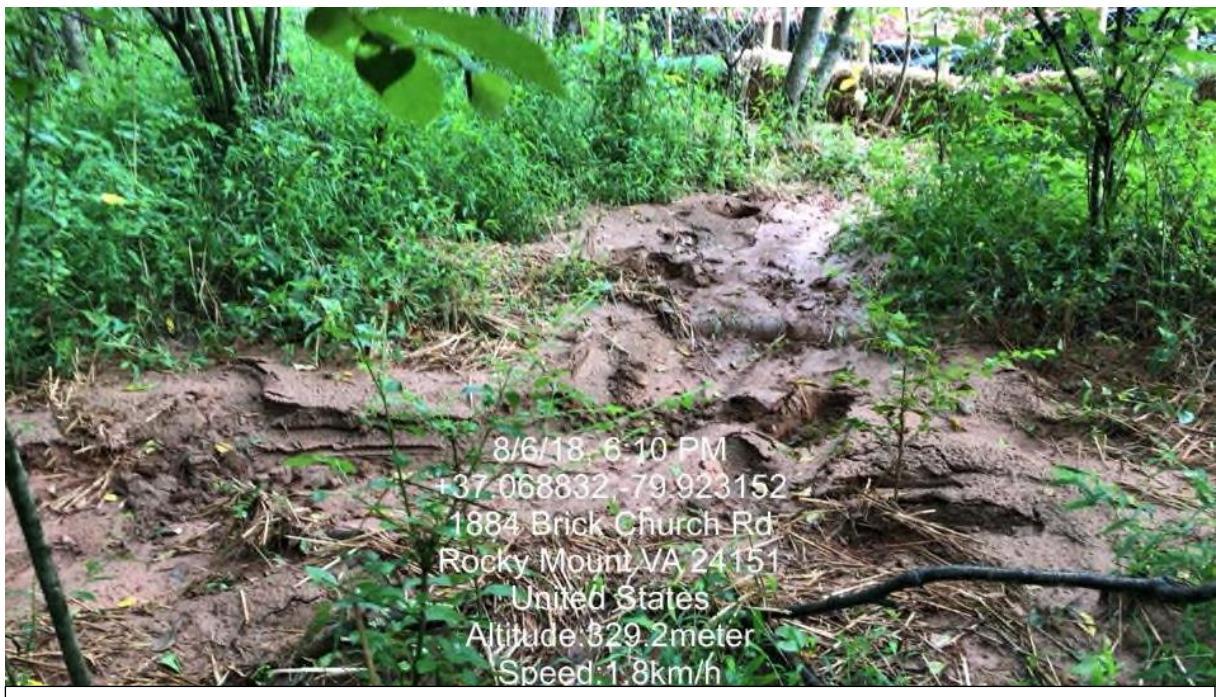
Figure 40 - Sediment deposits off ROW, at UT to Teels Creek, September 23, 2018, Source: citizen monitor

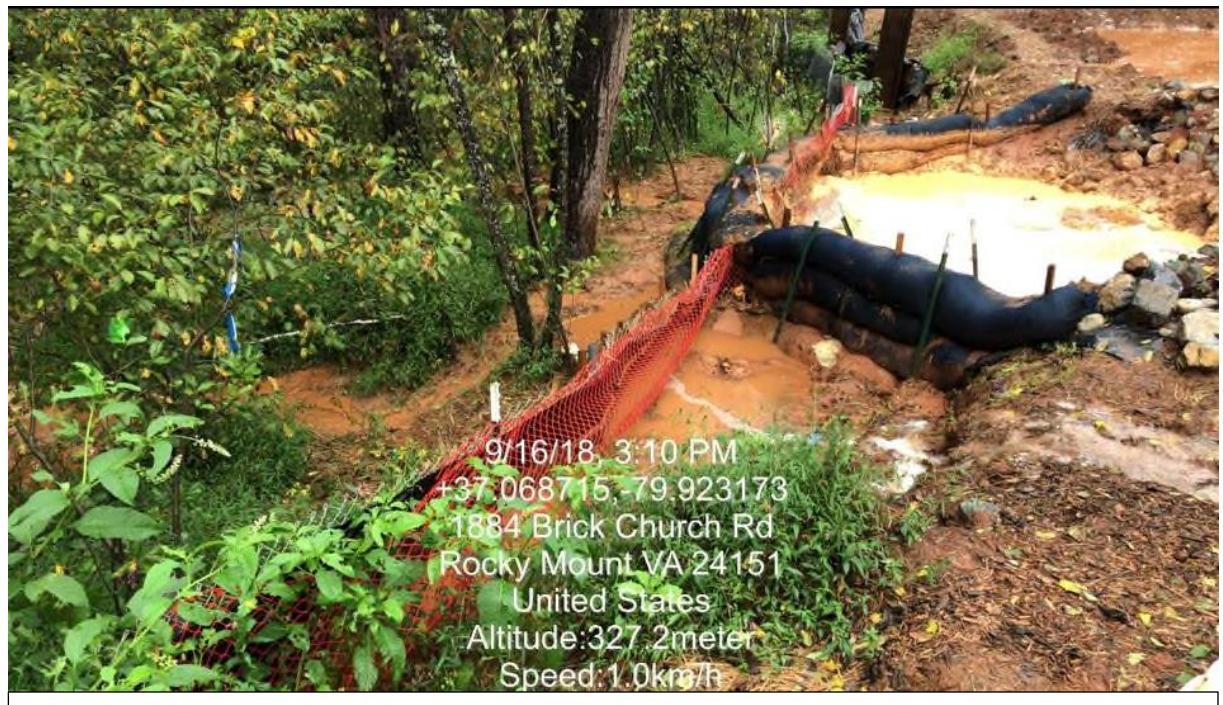
Figure 41 - Sediment deposits off ROW, at UT to Teels Creek, September 23, 2018, Source: citizen monitor.

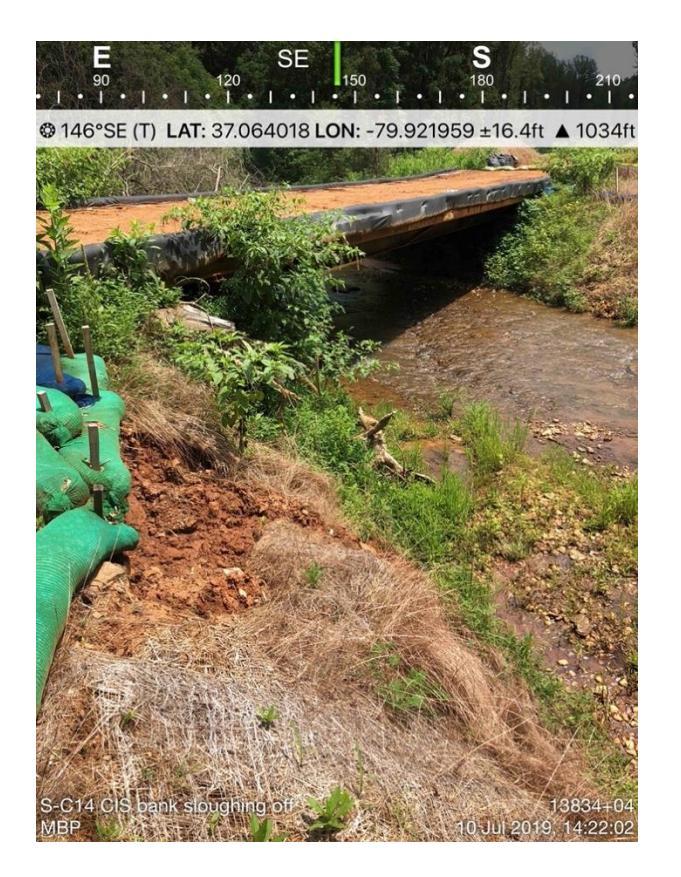
Figure 42 - Stream bank eroded at MVP site, Teels Creek, July 10, 2019, Action Log ID 3187, Source: MBP

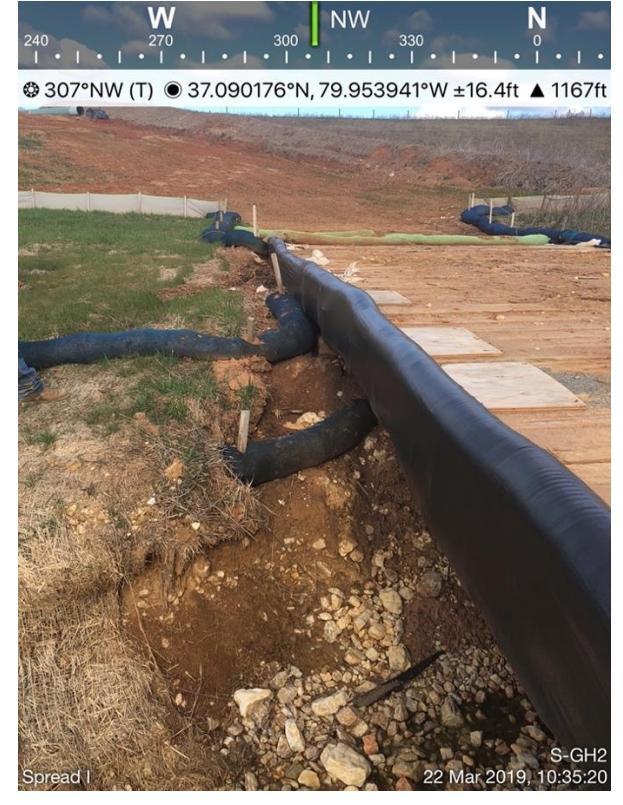
Figure 43 - Stream bank eroded at MVP site, UT Teels Creek, July 10, 2019, Action Log ID 2313, Source: MBP

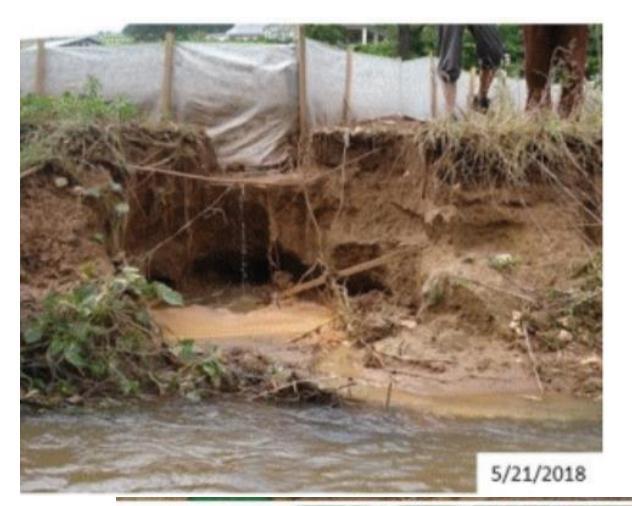
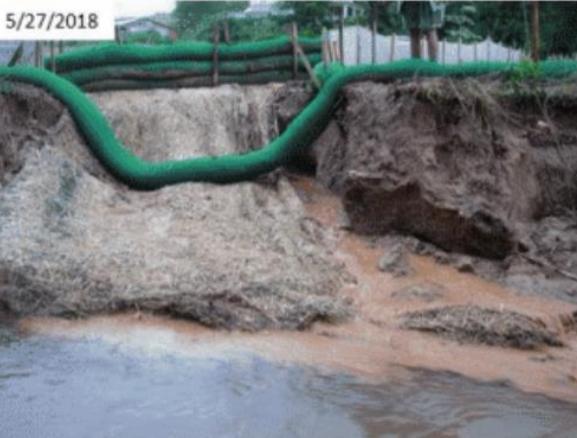
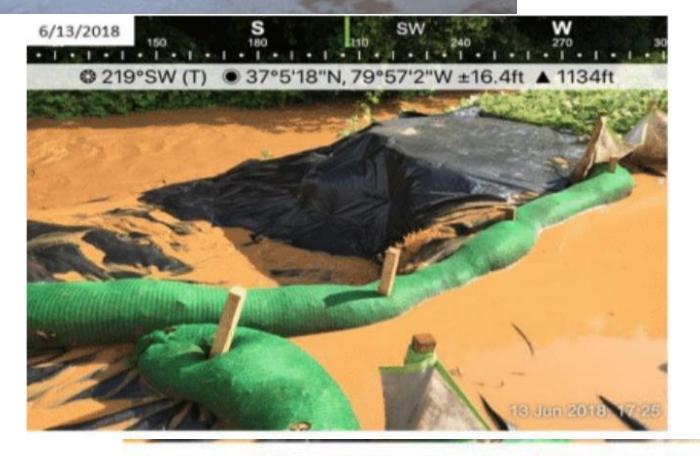
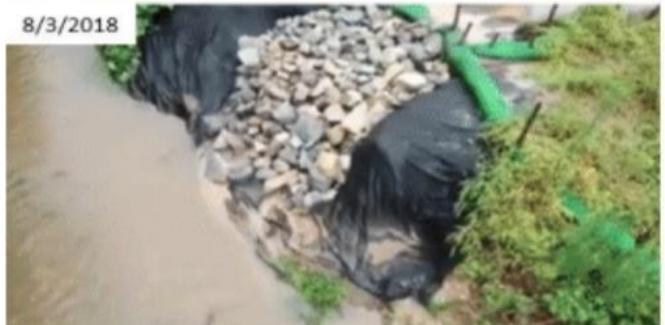
Figure 44 - A series of views of a collapsing stream bank on Teels Creek and Mountain Valley's attempts to repair the damage over several months in 2018. Source: Mountain Valley Watch Report, Appendix F to this report.

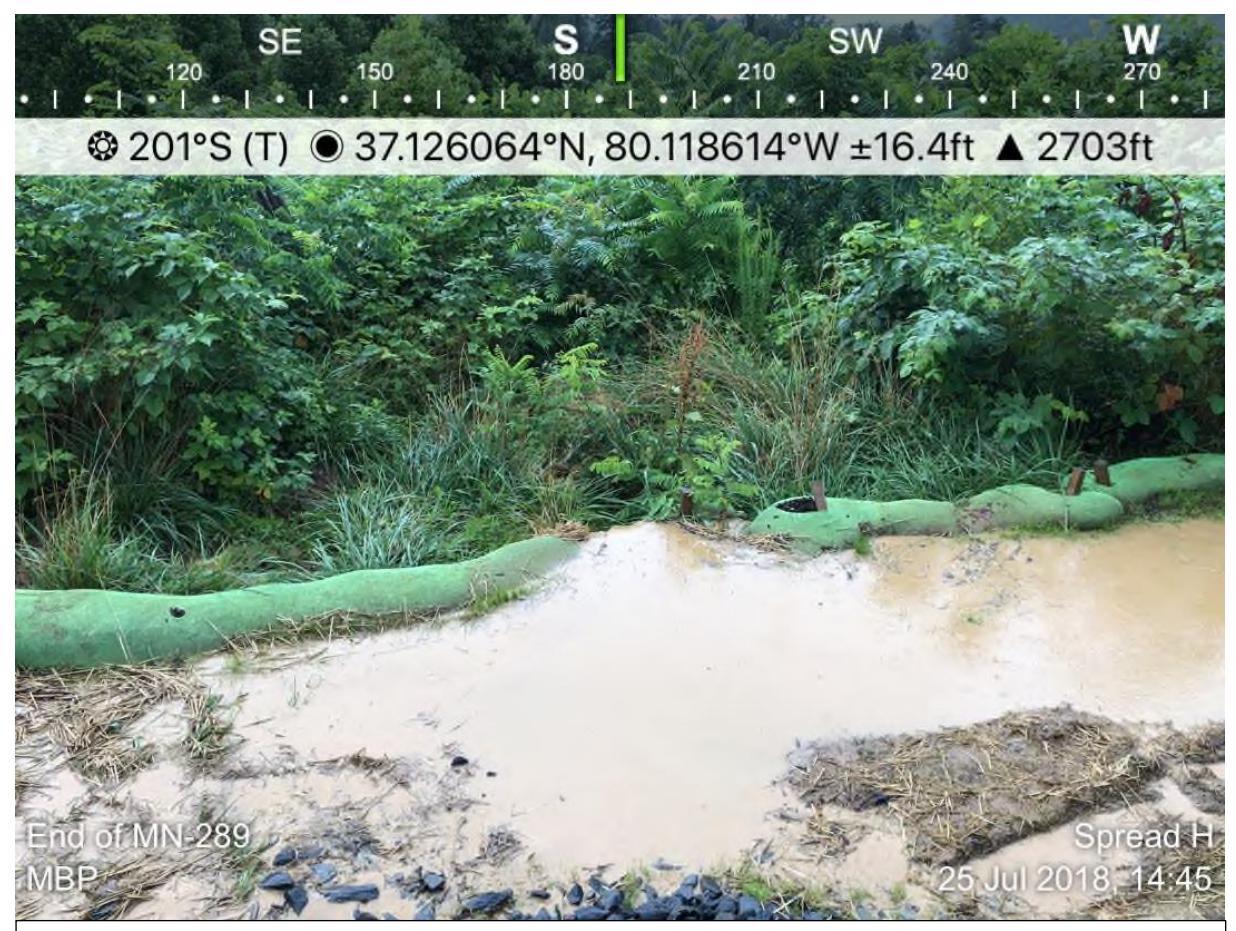
Figure 46 - Sediment-laden water overtopping perimeter control, July 25, 2018, Action Log ID 458, Source: MBP [an additional compost filter sock was added 10 days after this situation was observed]

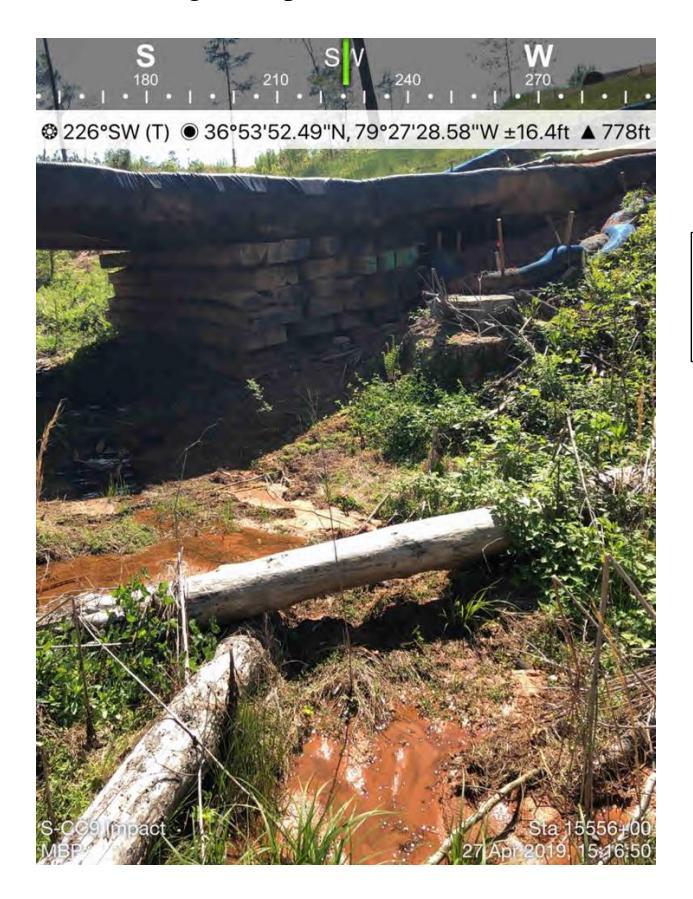
Figure 48 - Sediment deposited in UT to Cherrystone Creek, Action Item ID 2646, Source: MBP

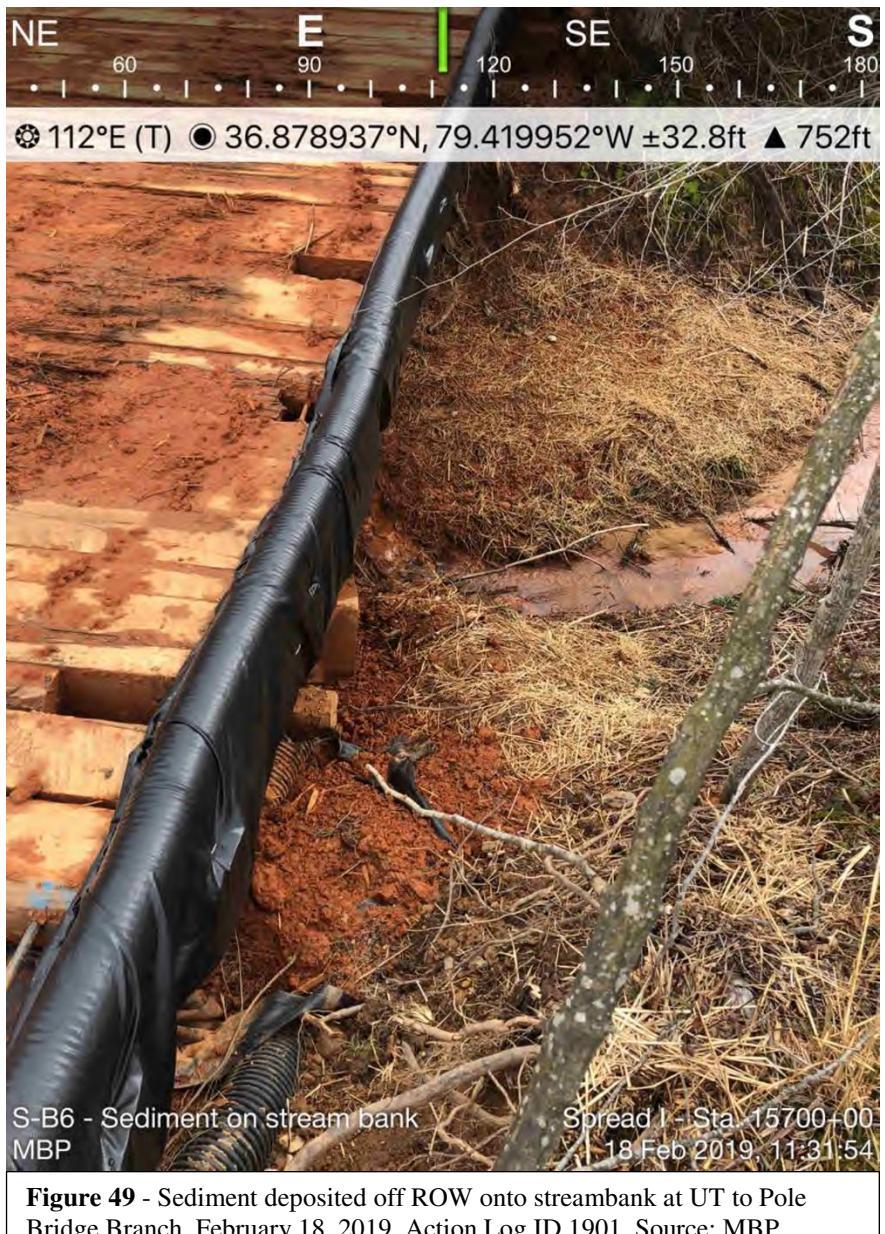
Bridge Branch, February 18, 2019, Action Log ID 1901, Source: MBP [deadline to remove extended "due to wet ROW," not removed until 6 days after deposited]
